Manhole Inspection Summary

Manhole # S43E__034MH

Insp Date: **6/10/08 8:38 AM**

Location Address: **2 s broadway**

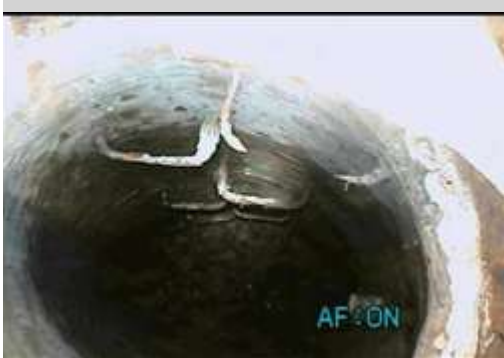
Defect 2

Count: **6** Missing: **1** ☒ **Corroded**

missing/corroded steps

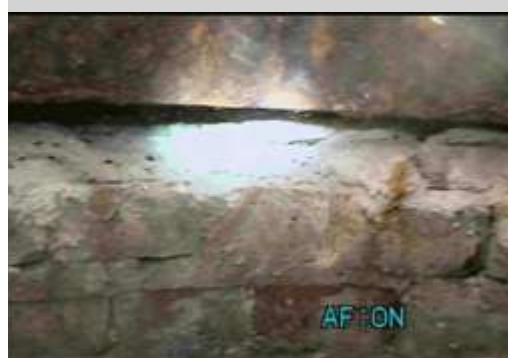
Defect 1

Condition: ☐ Sound ☐ Cracked ☐ Root Intrusion ☐ Loose Brick ☒ **Deteriorated**

chimney deteriorated, frame adj

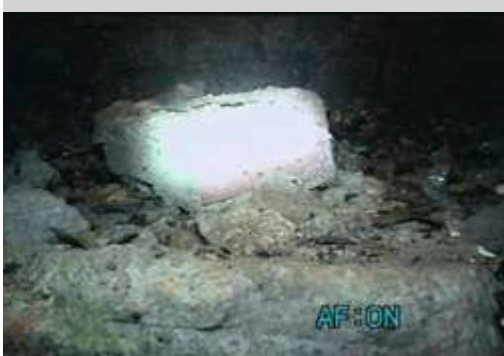
Defect 3

Condition: ☐ Sound ☐ Cracked ☐ Root Intrusion ☐ Deteriorated ☐ Leaks ☒ **Debris**

channel debris

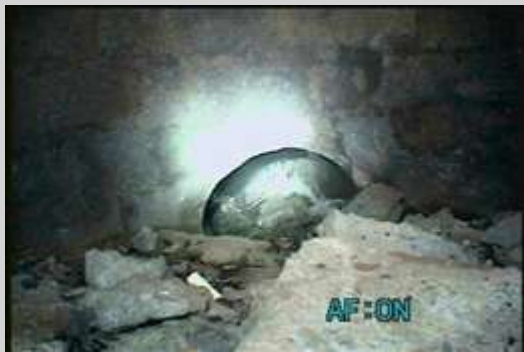
12 O'Clock Outflow

Deposits: ☐ None ☐ Mud ☐ Sludge ☒ **Debris** ☐ Grease

Silt Depth: 2 (in.) Deposits Extent: **Light**
